MATERIALS RESEARCH FOR THE CLEAN UTILIZATION OF COAL

QUARTERLY PROGRESS REPORT

July - September 1980

Center for Materials Science
National Bureau of Standards
U. S. Department of Commerce
Washington, D. C. 20234

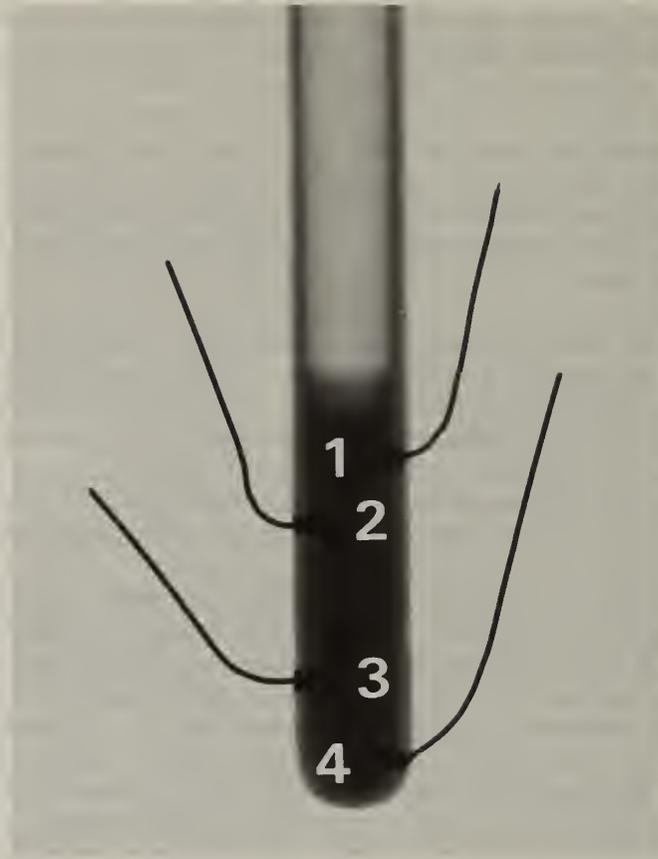
Figure 1. Radiograph of a typical slag sample. Platinum probes 1, 2, 3, and 4 are shown with probes 2 and 3 being the conductivity pair; and probes 1 and 4, the pair where current is introduced to the sample.

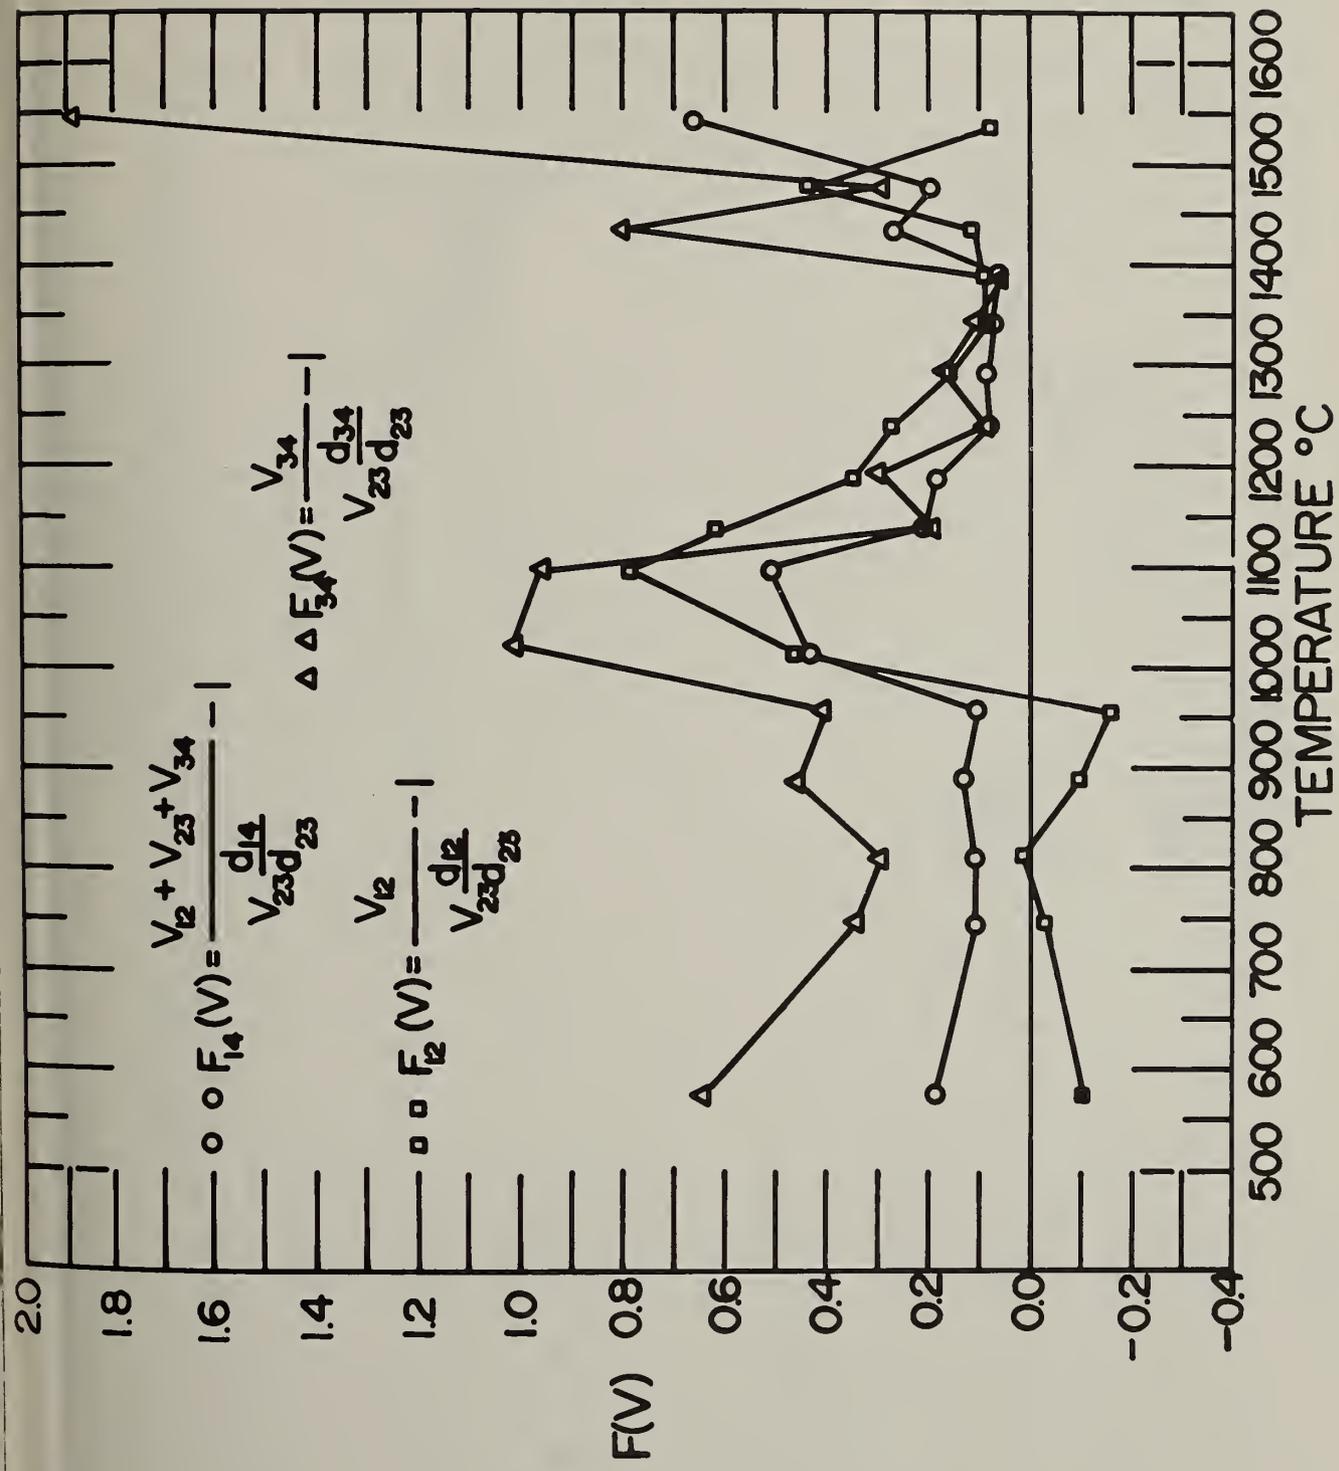
Figure 2. Plot of the DC values for equations 1, 2, and 3 as a function of temperature for increasing temperature.

It is apparent that there are substantial differences between the curves for increasing and for decreasing temperatures below 1300 °C. This will be discussed later. It should be noted, however, that at temperatures above 1300 °C both figures show a marked increase in the $f(V)$ values (with the exception of $f_{12}(V)$) which indicates an increase in the polarization effects because of enhanced ionic conductivity. Electric fields along the sample were kept at approximately 1 volt/cm in order to avoid possible permanent polarization. A more dramatic increase in the $f(V)$ values would be observed using higher electric fields.

At temperatures above 1300 °C, the 40Hz AC data shown in Figures 4 and 5 remain near zero in contrast to that data for the DC case (Figures 2 and 3). Polarization effects are not observed at 40Hz or over the frequency range measured and as a result, the $f(V)$ values remain near zero.

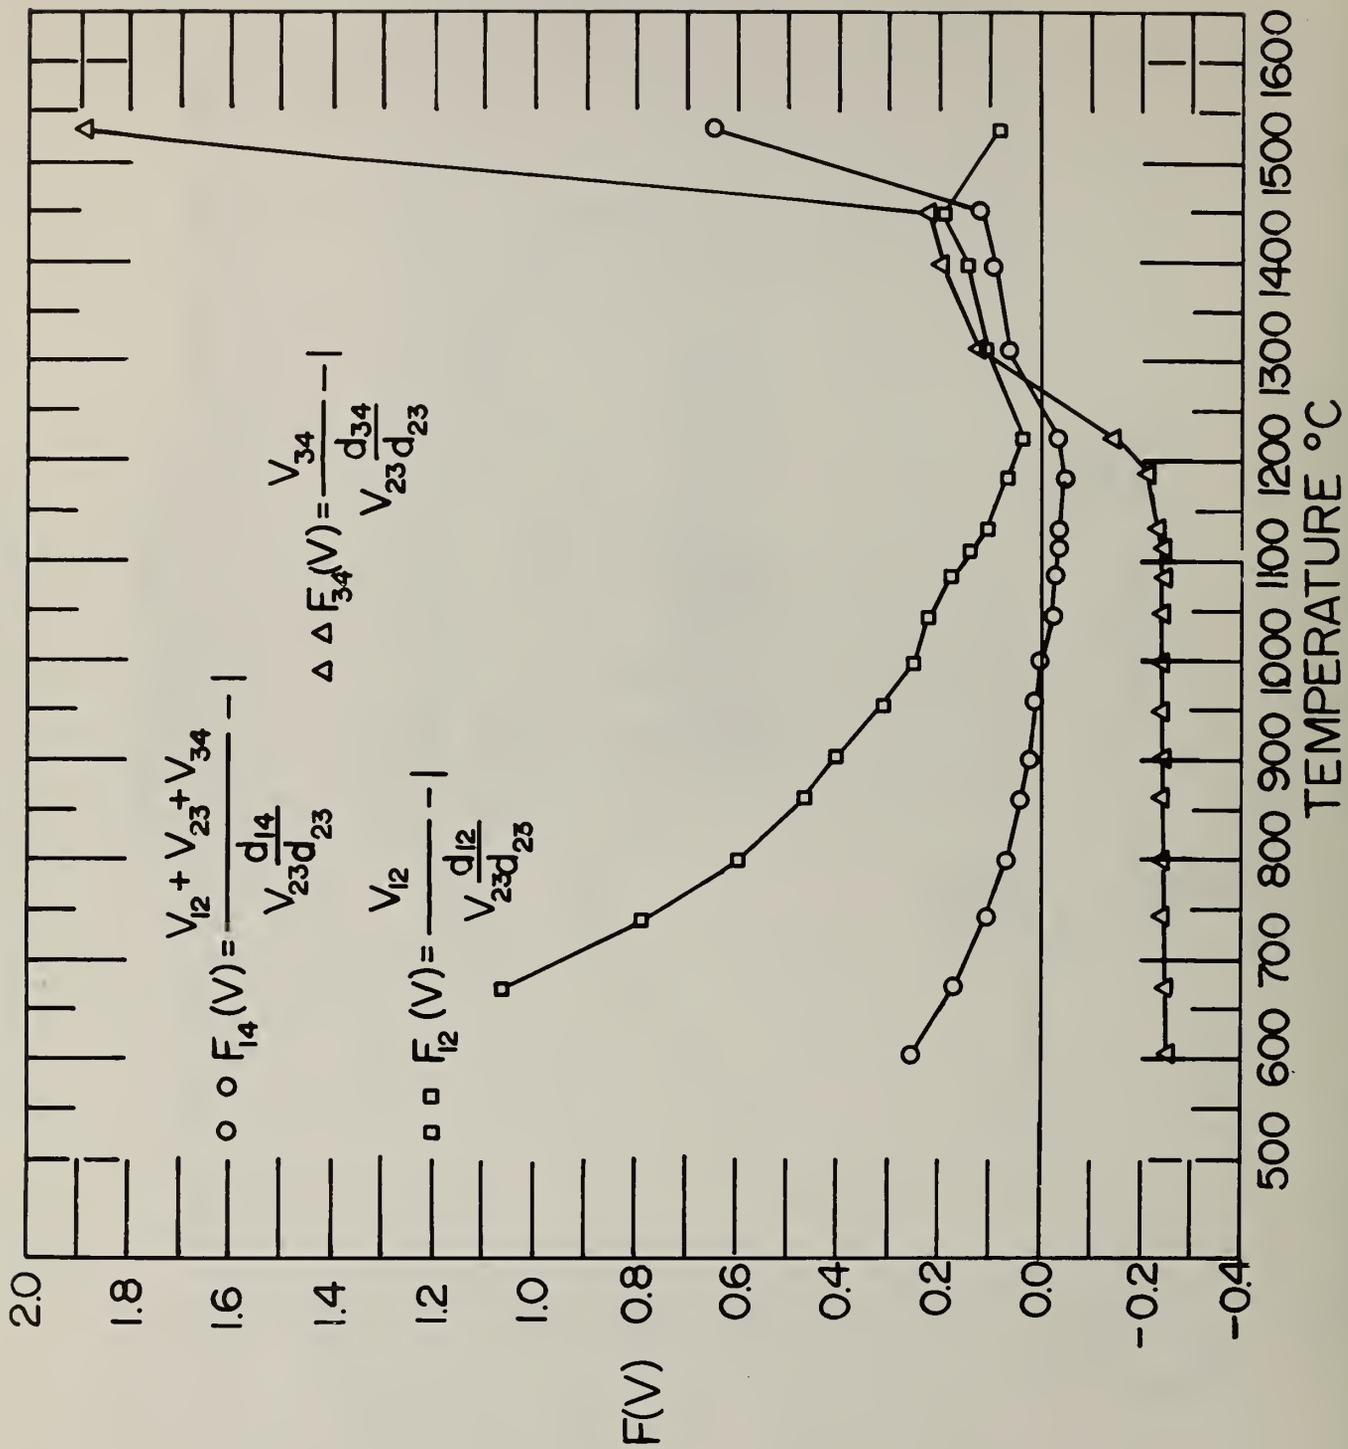
Figure 3. Plot of the DC values for equations 1, 2, and 3 as a function of temperature for decreasing temperature.

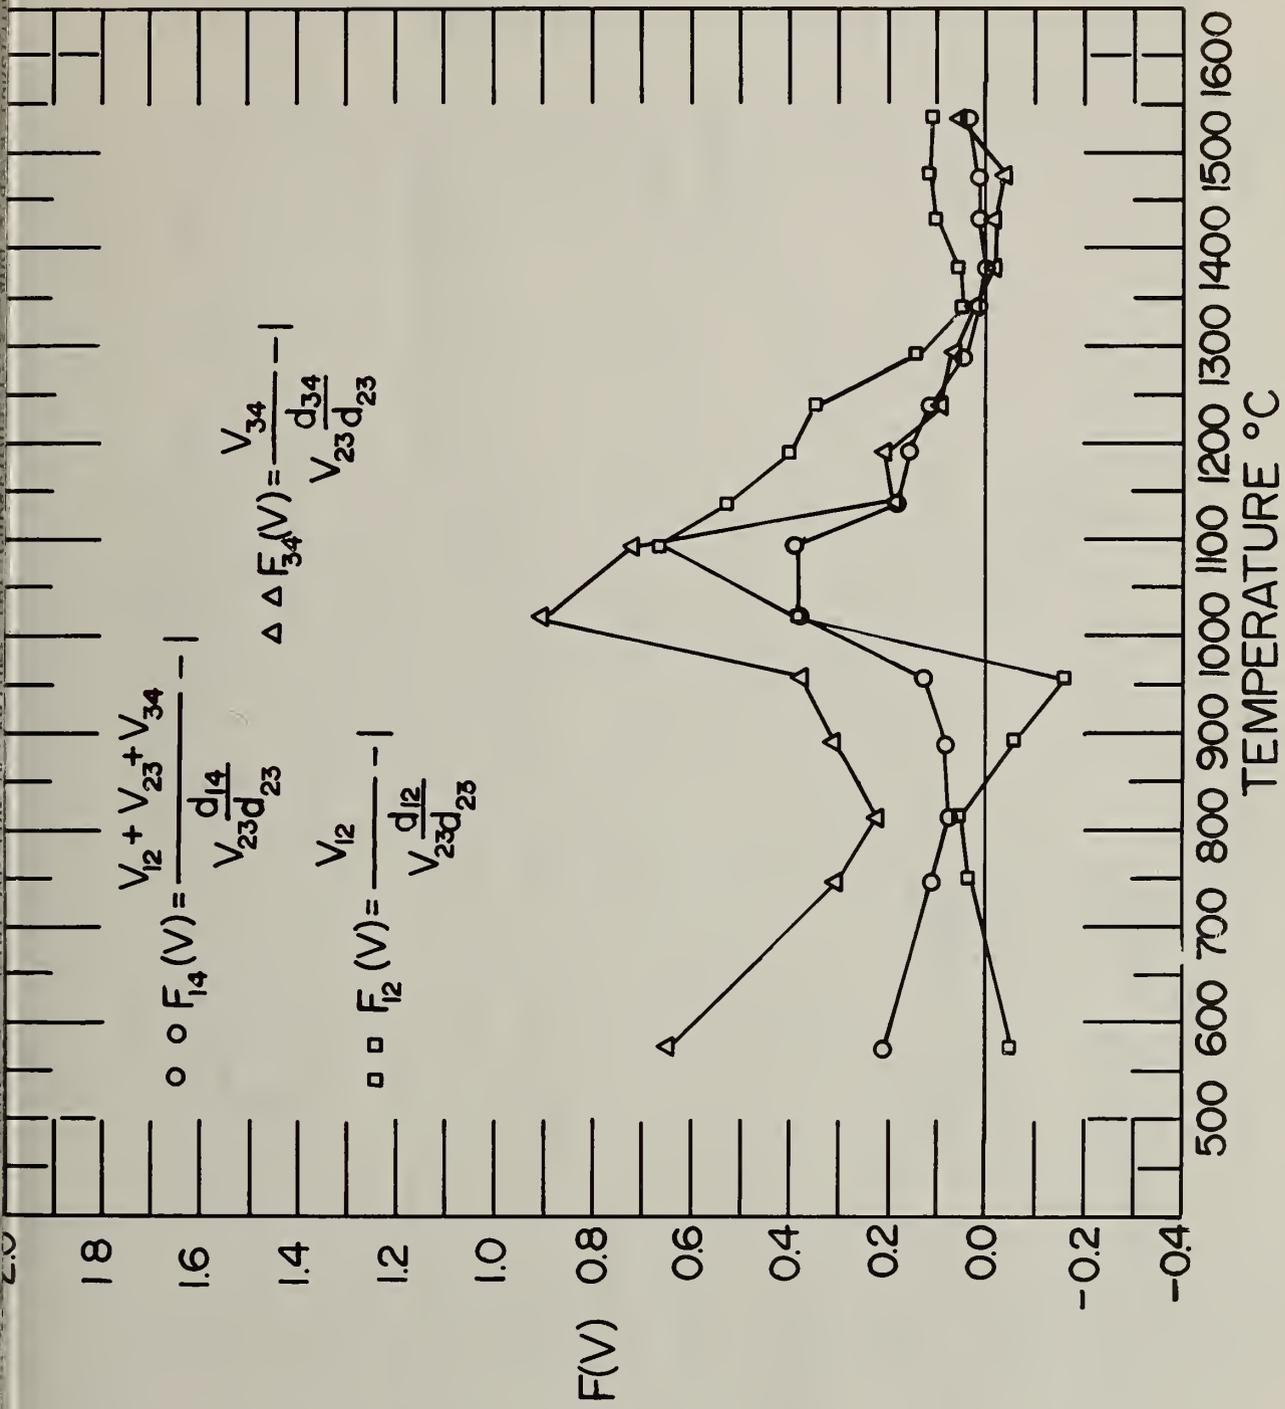
Figure 4. Plot of 40Hz AC values for equations 1, 2, and 3 as a function of temperature for increasing temperature.

Figure 4 shows the data at 40Hz for $f(V)$ values of the equations 1, 2, and 3 for increasing temperature, while Figure 5 gives the data for decreasing temperature. Since this was the same sample as the DC case and measured at the same time, the sample conditions should be the same.

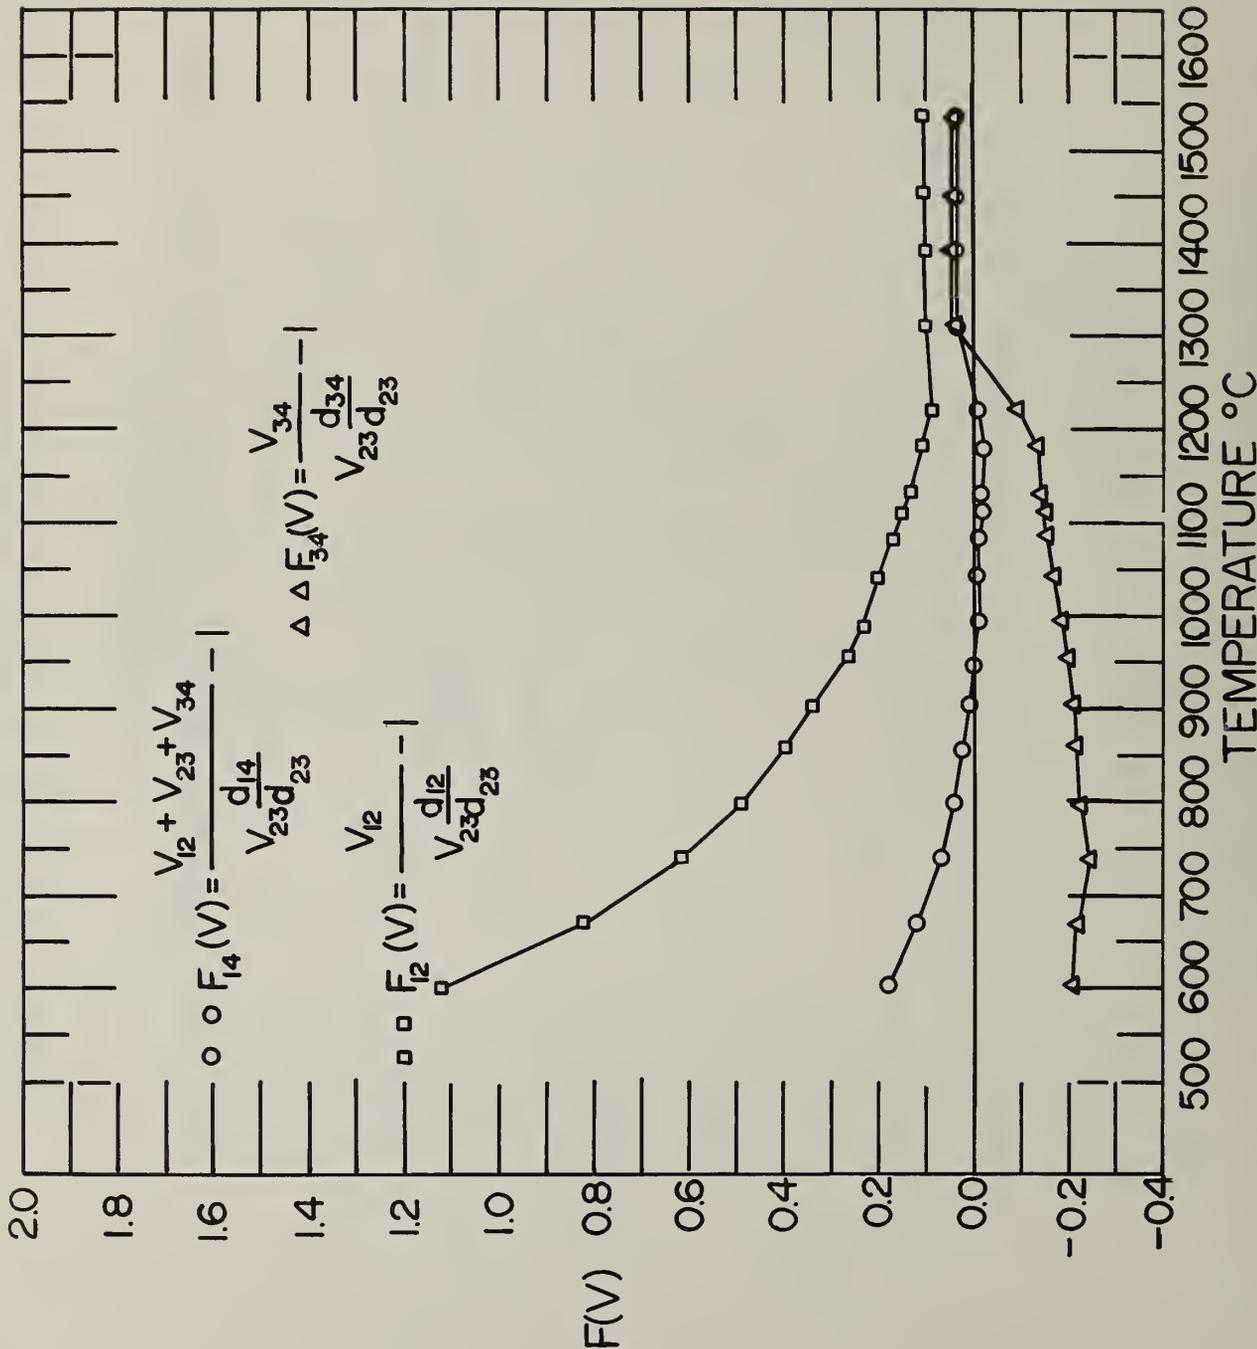
Figure 5. Plot of 40Hz AC values for equations 1, 2, and 3 as a function of temperature for decreasing temperature.

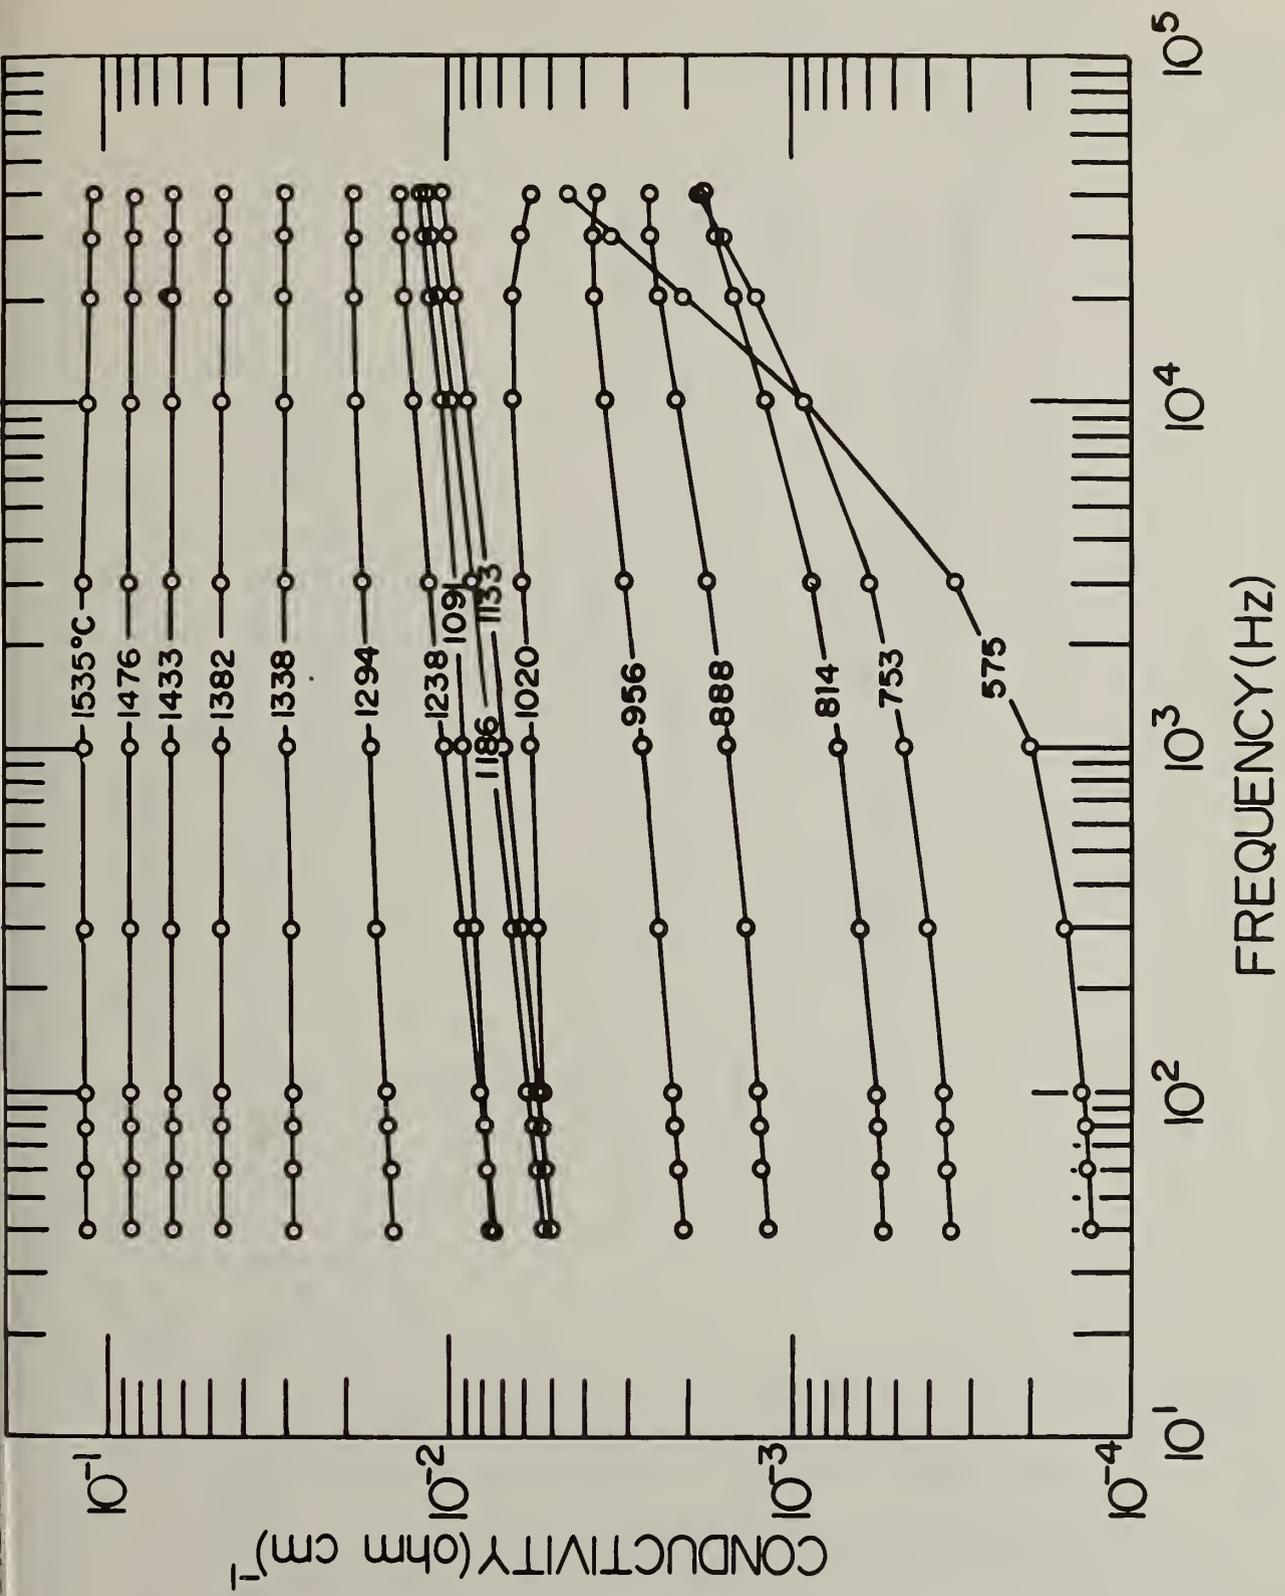
Figure 6. Conductivity as a function of frequency over a range of increasing temperatures.

Figure 6 is a plot of the conductivity as a function of frequency for the data taken with increasing temperature points while Figure 7 is the same data taken with decreasing temperature. The increase in conductivity with increasing frequency at lower temperature in each case may be due to the capacity of the twisted lead pair from the sample to the data acquisition system. A rough calculation of this capacity leads to an impedance value at 40KHz of the same order of magnitude as the resistance observed between the conductivity probes. A room temperature measurement of the capacitive reactance of the lead pairs has confirmed this calculation.

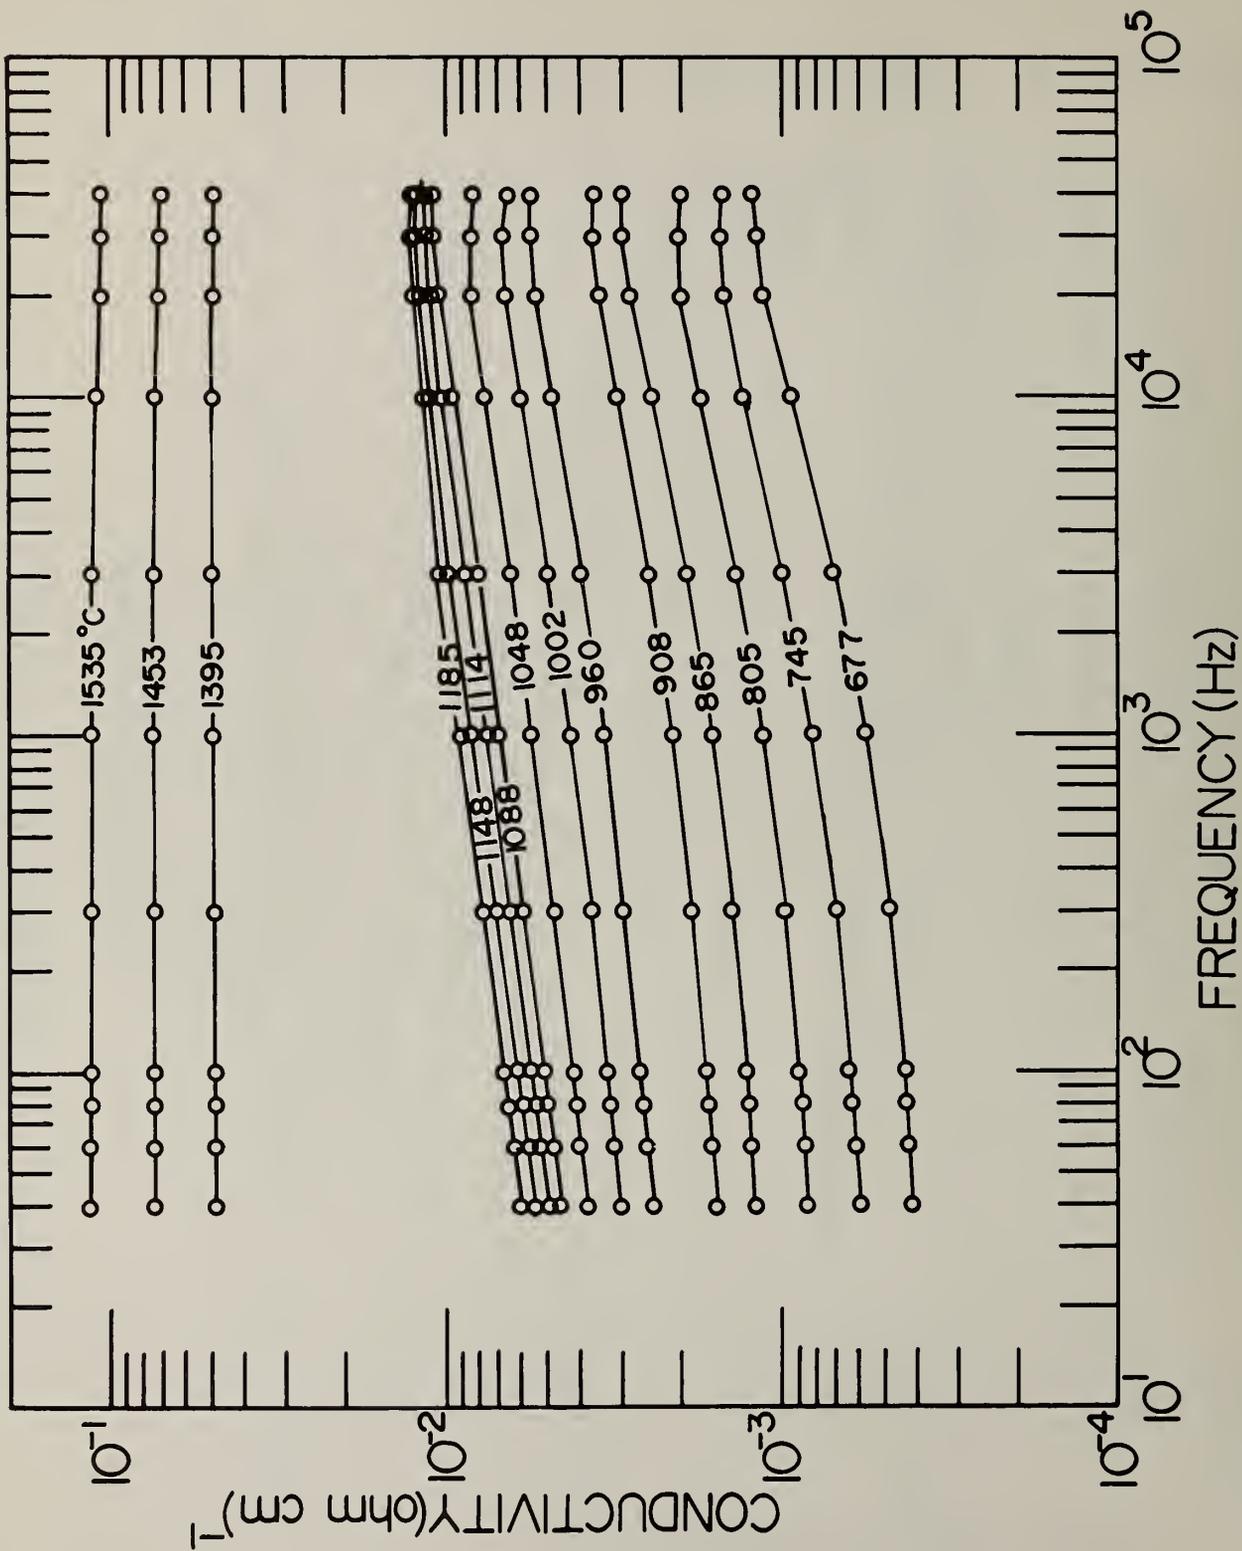
Figure 7. Conductivity as a function of frequency over a range of decreasing temperatures.

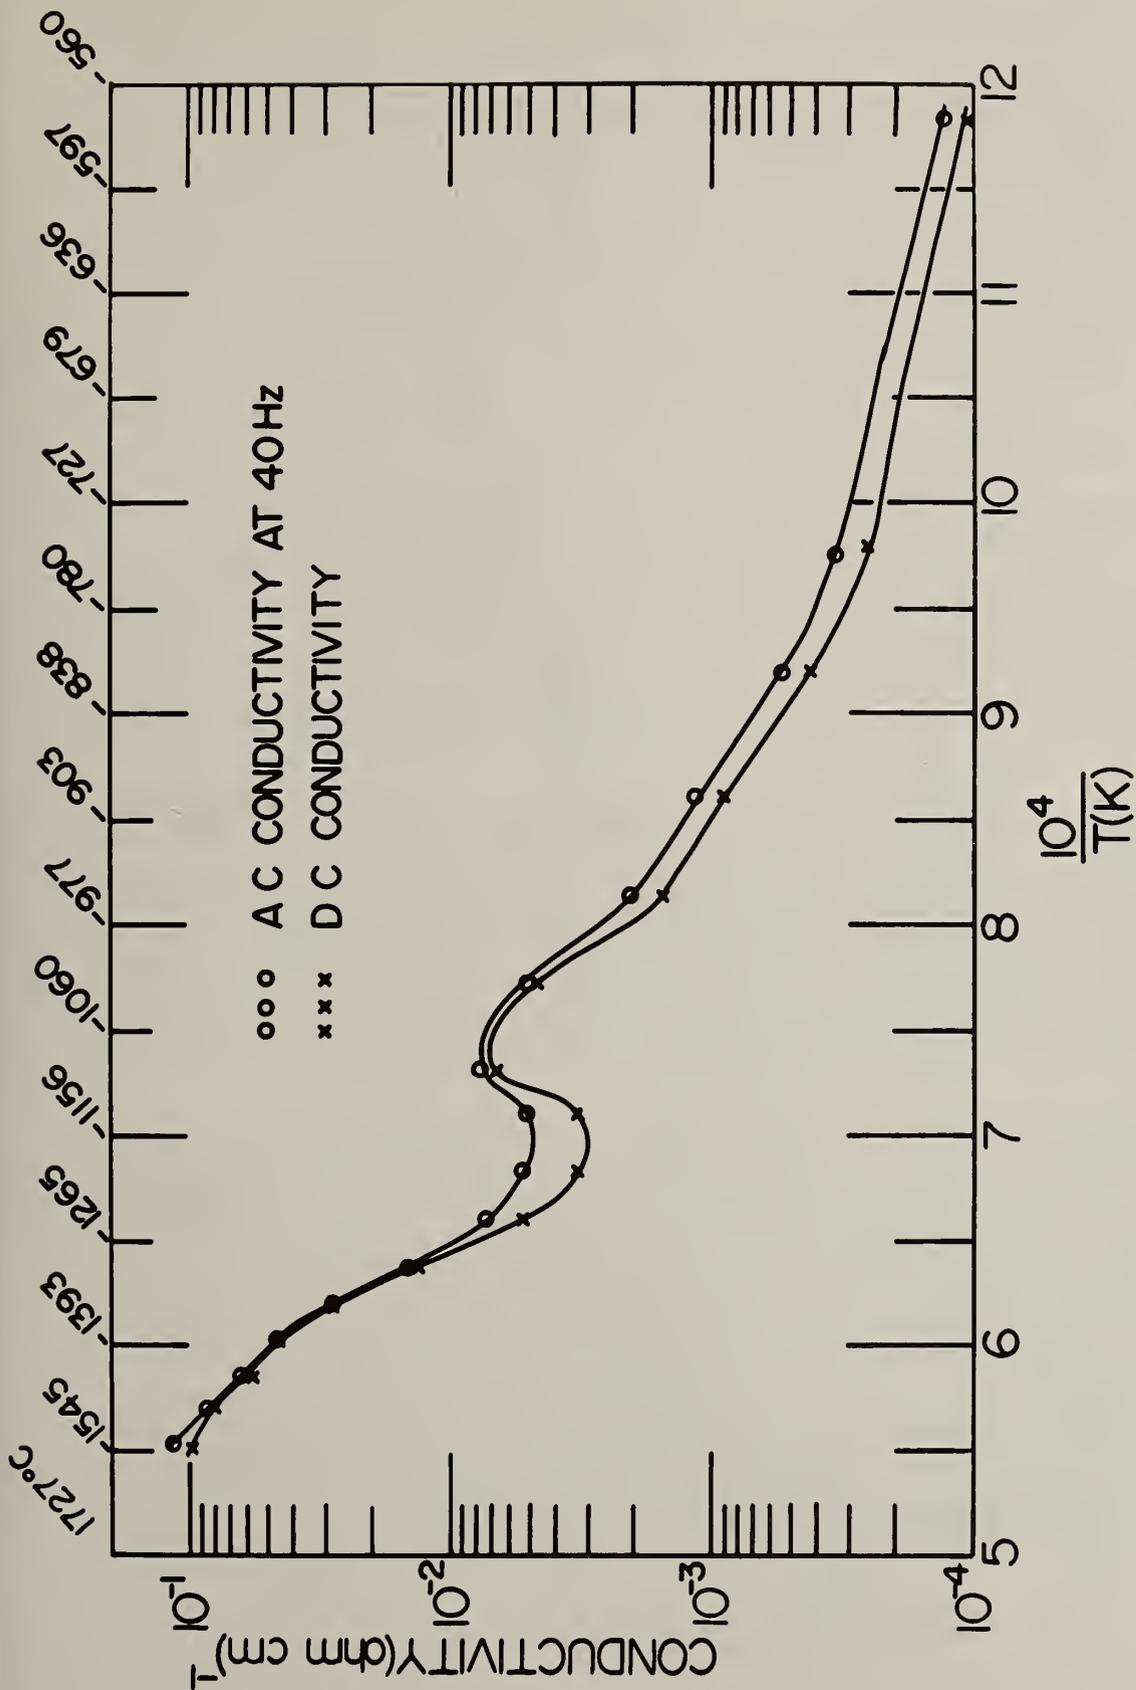
Figure 8. DC and 40Hz conductivity as a function of increasing temperature after sample preparation.

Figure 8 shows the AC (40Hz) and DC conductivity taken with increasing temperature. The maximum at about 1100 °C and the minimum at 1150 °C are distinct although the AC and DC values at the minimum differ by nearly a factor of two. They are in near exact agreement, however, above 1385 °C

where ionic conductivity is predominant and nearly equal below 1000 °C where the slag is solid and electronic conductivity is probably predominant.

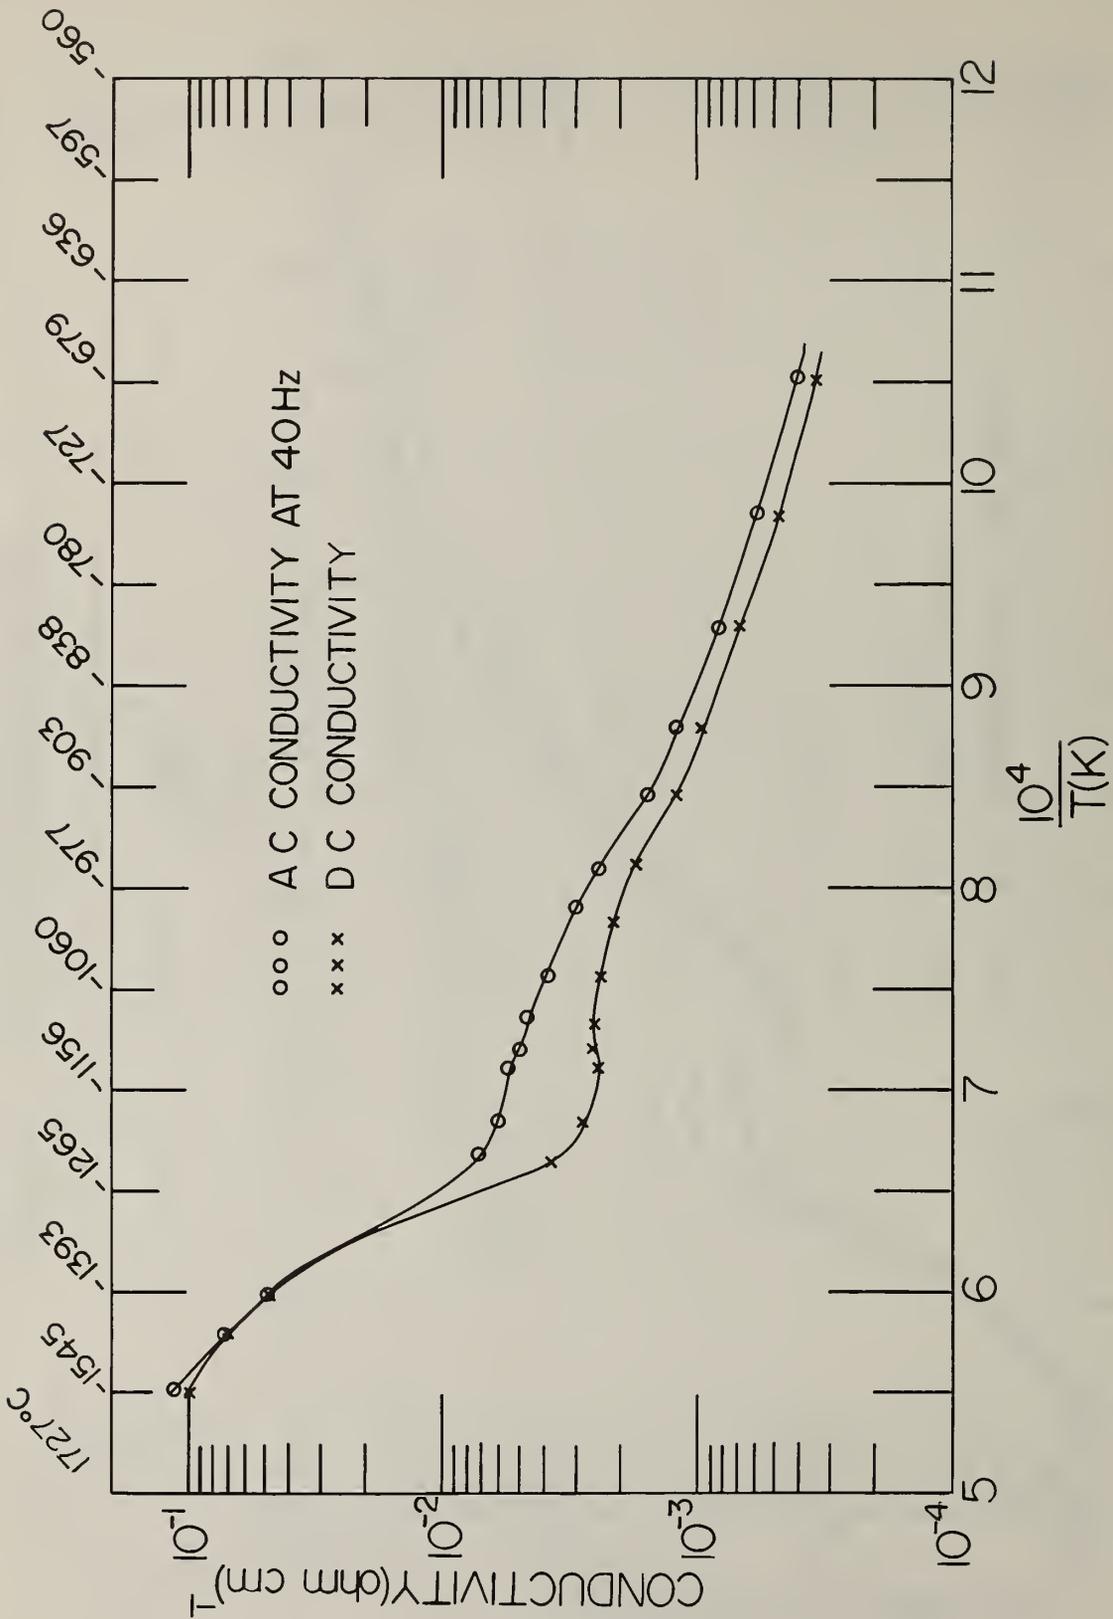
Figure 9. DC and 40Hz AC conductivity as a function of decreasing temperature from above 1500 °C.

Figure 9 shows the AC (40Hz) and DC conductivity as a function of decreasing temperature. In this case, there is only an inflection point near 1150 °C and the AC and DC values differ again by about a factor of two. Since for both the increasing and decreasing temperature curves (Figure 8 and 9) careful attention was paid to obtaining equilibrated values, the reason for the difference in the curve shapes with increasing and decreasing temperatures is not clear. This should be investigated by SEM methods in an effort to determine the sample conditions under the two different situations.

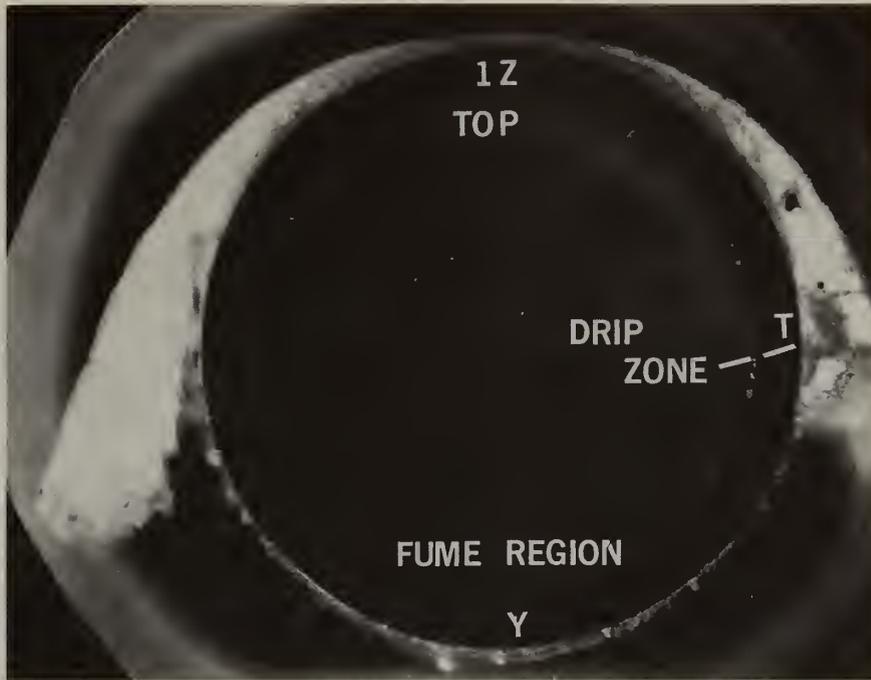
Fig. 1. Optical micrograph of a section of Type 316 stainless steel tubing after exposure to an oxygen rich hot gas stream seeded with K_2SO_4 and K_2CO_3 . Tube temperature $590^\circ C$. Note deposit on upper surface of tube.

An evaluation of specimens 8-6 (Figure 1) and 9-6 (Figure 24) can be made simultaneously. Both samples were seeded with 80% by weight K_2CO_3 and 20% by weight K_2SO_4 , with wall temperatures of 590 °C, however, 8-6 was in an oxygen rich fuel environment and 9-6 was in a fuel rich environment. The variations in the salt deposit can readily be observed with the oxygen rich specimen (8-6) exhibiting a top deposit of 0.3 mm, drip deposit of 2 mm and a slight fume deposit. The fuel rich specimen (9-6) shows a top coating of 0.1 mm, drip deposit of 1.6 mm and a very unusual fume deposit region, dendritic in nature. Photos (Figures 2 and 3) show a banding property in the deposit with K + S near the surface of the steel followed by a high K region with a thin band of K + S on the surface. This phenomenon is also seen in the

The corrosion process exhibited in both specimens seem to follow the same general corrosion mechanism. In sample 8-6 (oxygen rich) at the leading edge, salt-stainless interface (Figures 1, 4-12) we find the bulk stainless followed by a reaction zone area where high nickel is found with chromium and iron followed by an area of high chromium, high iron, nickel and potassium. Chromium and iron are then found penetrating the salt deposit with the iron being the most mobile species and moving far into the salt deposit. Nickel being the least mobile or least reactive species is generally not found to penetrate the salt deposit except at the interface where chromium and iron move rather readily through the salt.

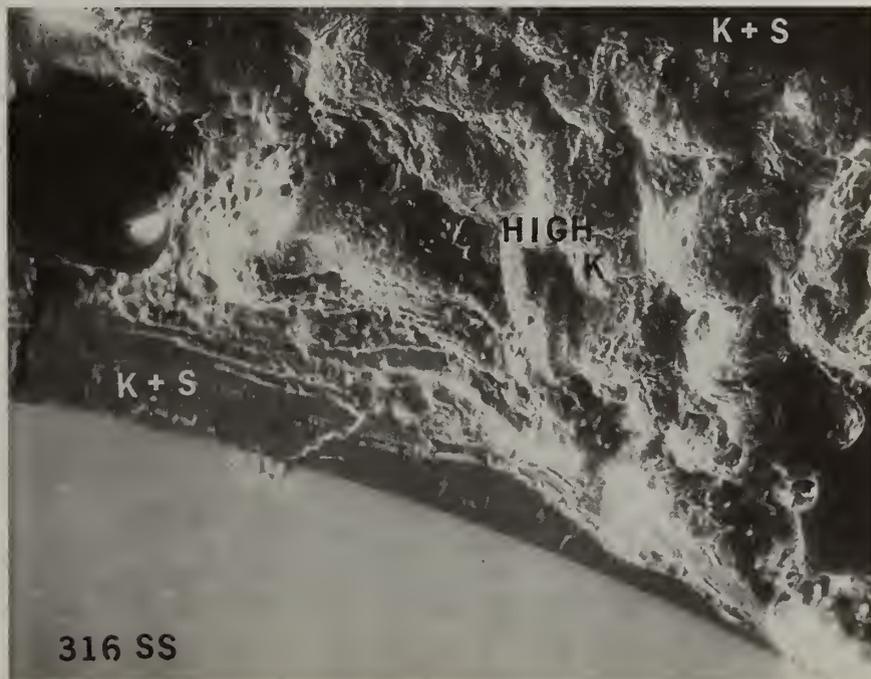
Fig. 2. SEM micrograph, 45 X, of region T of optical micrograph Fig. 1 showing metal-salt deposit interface in the drip zone.

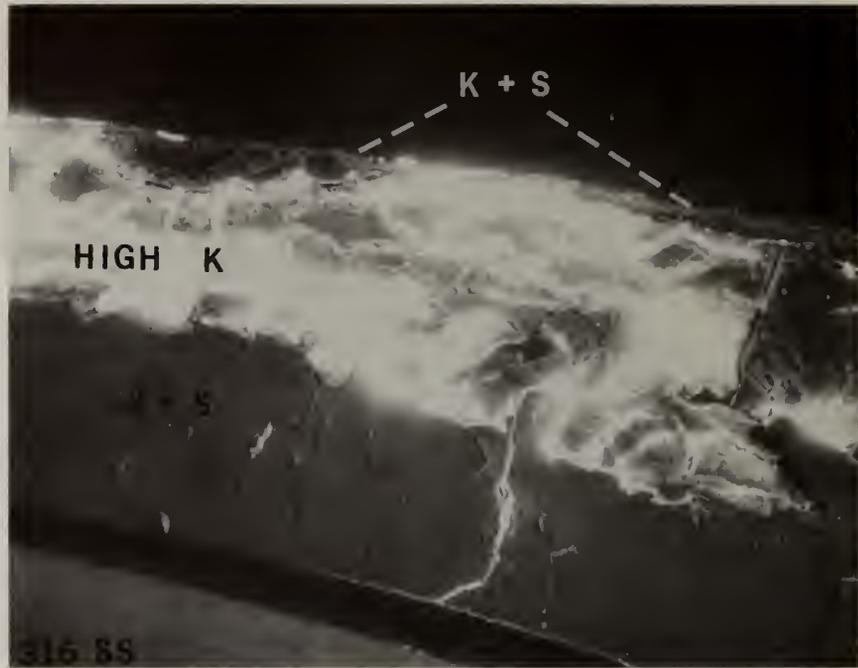
Fig. 3. SEM micrograph, 92 X, of region T of optical micrograph Fig. 1 showing metal-salt deposit interface in the drip zone.

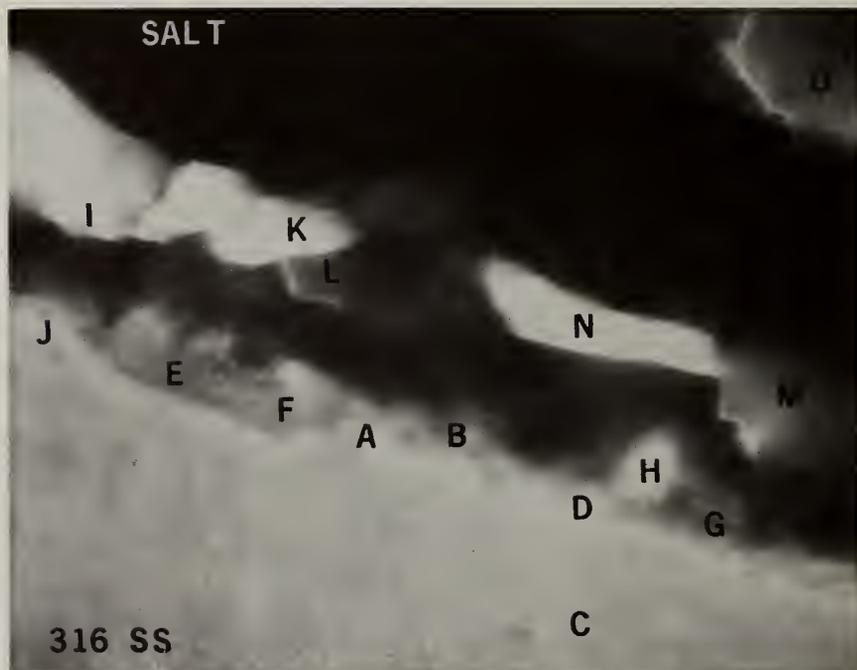
Fig. 4. SEM micrograph, 5460 X, of region 1Z of optical micrograph Fig. 1 showing reaction area at metal-salt interface. Lettered regions correspond to labeled EDX spectra Fig. 5-12.
